**Flood Control Project Maintenance
Levee Inspections****LMA District Cover Sheet****Spring 2014 Levee Inspection Results****Reclamation District No. 0404 Boggs**

Spring 2014 Levee Inspection Results

Reclamation District No. 0404 Boggs

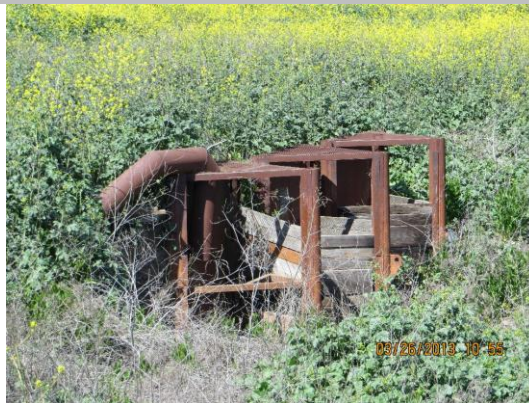
Photo 1 of 2 : UCIP_593.jpg

LM Start	0.66	Rating **	M	Issue No.	28
LM End	0.66	Issue Type +	En	Location *	WS
Category	Supplemental			GPS Latitude/Longitude	
				Start	End
Item	DWR UCIP Field Study			37.938670 °	37.938670 °
				-121.335397 °	-121.335397 °
DWR ID	DWR_RD0404_01_s_2014_28				
Action/Comments					
Inspector Comments: FS_ID:11087					
EP_NO: N/A					
Repair Type:					
Crossing Status:					
UCIP Comments: Steel intake structure on landside of the levee.					
FIELD_STRUCT_DESC: 2 of 3. 30-inch pipes through levee, 22.0 feet below the crown. Waterward end with flap gates. Landward end filled with dirt. Steel intake structure on landside of the levee. Middle flap gate missing and right flap gate broken as of 1/24/07.					
FS Date: 3/26/2013

LS- intake structure

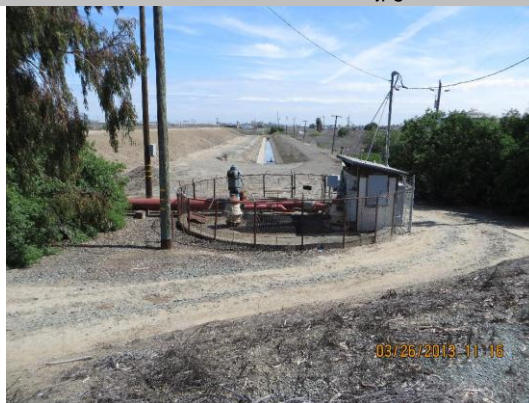
Photo 1 of 1 : UCIP_590.jpg

LM Start	0.76	Rating **	M	Issue No.	30
LM End	0.76	Issue Type +	En	Location *	LS
Category	Supplemental			GPS Latitude/Longitude	
				Start	End
Item	DWR UCIP Field Study			37.937657 °	37.937657 °
				-121.334158 °	-121.334158 °
DWR ID	DWR_RD0404_01_s_2014_30				
Action/Comments					
Inspector Comments: FS_ID:11188					
EP_NO: N/A					
Repair Type:					
Crossing Status:					
UCIP Comments: Tilted headwall on WS. Partially burried flap gate					
FIELD_STRUCT_DESC: 42-inch CM drainage pipe through levee 18.0					
feet below crown. Flap gate, concrete headwall and spillway on the					
waterward side. Pumphouse on landward side. O&M #: SJR 001					
FS Date: 3/26/2013

LS- pumping plant over large concrete riser

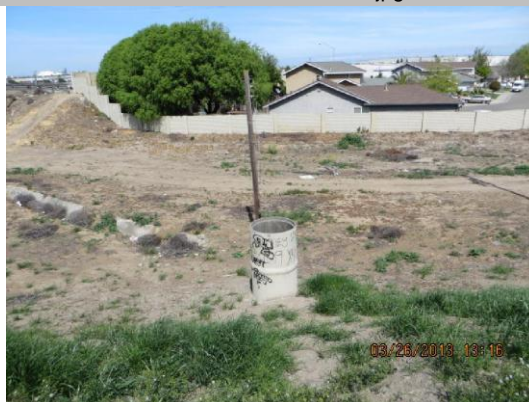
Photo 1 of 1 : UCIP_606.jpg

LM Start	1.65	Rating **	M	Issue No.	32
LM End	1.65	Issue Type +	En	Location *	LS
Category	Supplemental			GPS Latitude/Longitude	
				Start	End
Item	DWR UCIP Field Study			37.928090 °	37.928090 °
				-121.326215 °	-121.326215 °
DWR ID	DWR_RD0404_01_s_2014_32				
Action/Comments					
Inspector Comments: FS_ID:11163					
EP_NO: N/A					
Repair Type:					
Crossing Status:					
UCIP Comments: Abandoned crossing. WS pipe capped with steel pipe and LS pipe cut.					
FIELD_STRUCT_DESC: Abandoned 14-inch irrigation pipe. 3.0 feet below levee crown.					
FS Date: 3/26/2013

LS- concrete standpipe on levee slope

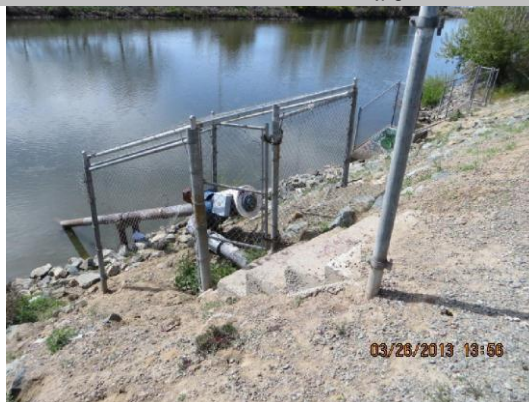
Photo 1 of 1 : UCIP_609.jpg

LM Start	1.81	Rating **	M	Issue No.	33
LM End	1.81	Issue Type +	En	Location *	LS
Category	Supplemental			GPS Latitude/Longitude	
				Start	End
Item	DWR UCIP Field Study			37.926168 °	37.926168 °
				-121.324514 °	-121.324514 °
DWR ID	DWR_RD0404_01_s_2014_33				
Action/Comments					
Inspector Comments: FS_ID:12387

WS- slanted pump, pipe, and concrete steps on levee slope.

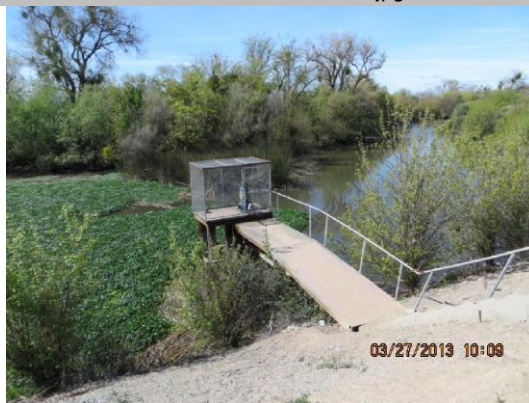
Photo 1 of 1 : UCIP_393.jpg

LM Start	0.73	Rating **	M	Issue No.	15
LM End	0.73	Issue Type +	En	Location *	CR
Category	Supplemental			GPS Latitude/Longitude	
				Start	End
Item	DWR UCIP Field Study			37.919336 °	37.919336 °
				-121.306782 °	-121.306782 °
DWR ID	DWR_RD0404_02_s_2014_15				
Action/Comments					
Inspector Comments: FS_ID:10908					
EP_NO: 3340A					
Repair Type:					
Crossing Status:					
UCIP Comments: - Not working for 5 years- Golf club staffWooden					
Walkway; Concrete stepsDamaged siphon breaker					
FIELD_STRUCT_DESC: 6-inch pipe through the levee, 2.0 feet below					
the crown. Pump on pile structure in stream. Shut-off valve and siphon					
breaker on the waterward shoulder. Timber walkway on the waterward					
slope. One CM cutoff wall. (Permit No. 3340A)					
FS Date: 3/27/2013

WS- pump on steel structure and wooden walkway

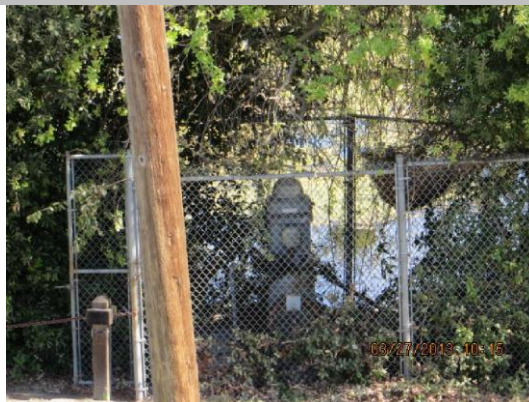
Photo 1 of 1 : UCIP_409.jpg

LM Start	0.73	Rating **	M	Issue No.	17
LM End	0.73	Issue Type +	En	Location *	CR
Category	Supplemental			GPS Latitude/Longitude	
				Start	End
Item	DWR UCIP Field Study			37.919308 °	37.919308 °
				-121.306714 °	-121.306714 °
DWR ID	DWR_RD0404_02_s_2014_17				
Action/Comments					
Inspector Comments: FS_ID:10945					
EP_NO: 4448					
Repair Type:					
Crossing Status:					
UCIP Comments: Concrete stairway on waterward slope- Not found.					
Pump was working during field survey. Siphon breaker cap missing.					
FIELD_STRUCT_DESC: 18-inch pipe through the levee, 9.3 feet below the crown, pump on the landward side. Siphon breaker in concrete well on the waterward shoulder. Two CM cutoff walls. (Permit No. 4448)					
FS Date: 3/27/2013

LS- pumping plant behind the fence.

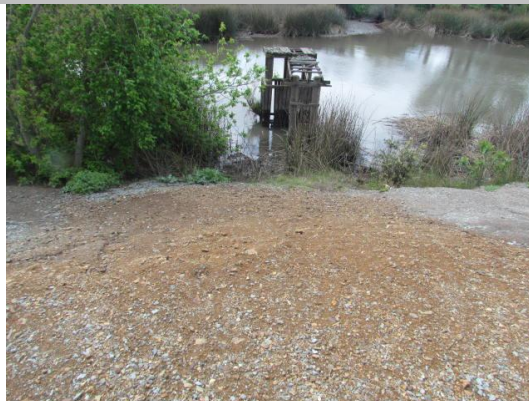
Photo 3 of 4 : richard_s_20140403_506.jpg

LM Start	1.13	Rating **	M	Issue No.	66 (cont)	
LM End	1.13	Issue Type +	Ma	Location *	WS	
Category	Earthen Levee			GPS Latitude/Longitude		
				Start		End
Item	Encroachments			37.916340 °	37.916340 °	
				-121.301898 °	-121.301898 °	
DWR ID	DWR_RD0404_02_s _ 2012_66					
Action/Comments						
Equipment

Looking southwest at repaired site.

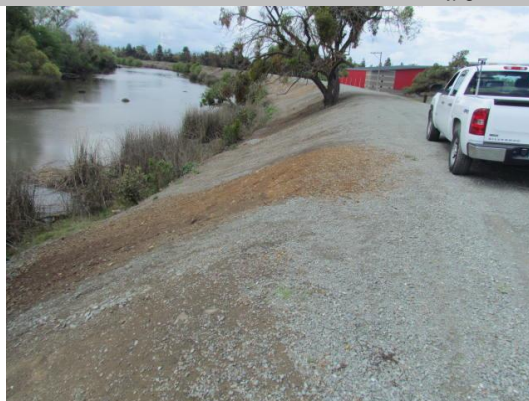
Photo 4 of 4 : richard_s_20140403_507.jpg

LM Start	1.13	Rating **	M	Issue No.	66 (cont)
LM End	1.13	Issue Type +	Ma	Location *	WS

Looking north at repaired site.

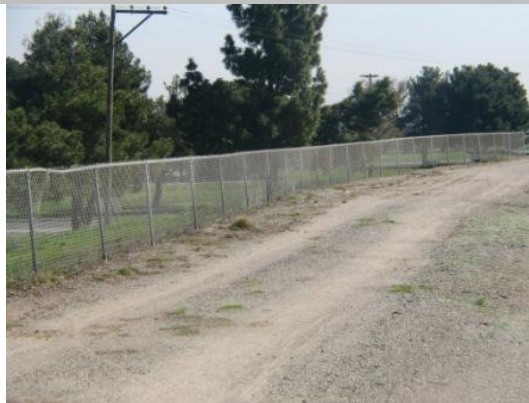
Photo 1 of 2 : richard_s_20140320_071.jpg

LM Start	1.47	Rating **	M	Issue No.	6
LM End	1.52	Issue Type +	En	Location *	LS
Category	Earthen Levee			GPS Latitude/Longitude	
				Start	End
Item	Encroachments			37.918440 °	37.918517 °
				-121.296707 °	-121.295763 °
DWR ID	DWR_RD0404_02_s _ 2012_6				
Action/Comments					
Fence Inspector Comments: District or Landowner has removed fencing, but still need to remove fence poles.

Fence at landside shoulder from LM 1.47 to 1.52

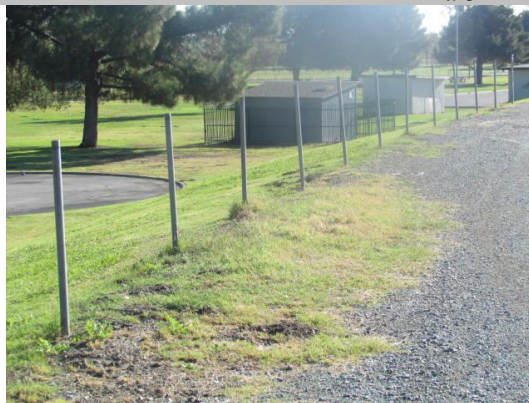
Photo 2 of 2 : richard_s_20140320_072.jpg

LM Start	1.47	Rating **	M	Issue No.	6 (cont)
LM End	1.52	Issue Type +	En	Location *	LS

Looking northeast at fence poles on landside shoulder.

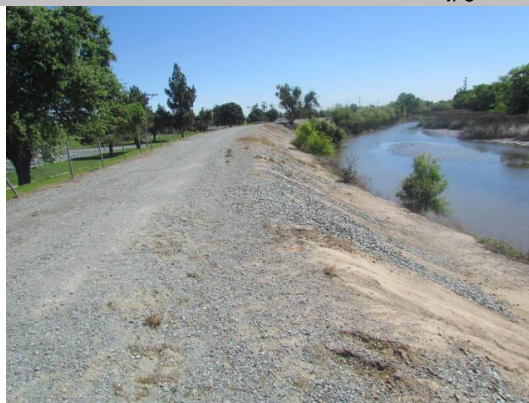
Photo 2 of 2 : richard_s_20140320_069.jpg

LM Start	1.47	Rating **	A/W	Issue No.	1 (cont)
LM End	1.53	Issue Type +	Ma	Location *	WS
Category	Earthen Levee			GPS Latitude/Longitude	
				Start	End
Item	Slope Stability			37.918490 °	37.918518 °
				-121.296650 °	-121.295690 °
DWR ID	DWR_RD0404_02_s _ 2012_1				
Action/Comments					
Repair slope instability. Inspector Comments: There are several foot traffic erosion sites along the waterside slope.

Looking southeast at repaired sites on waterward slope.

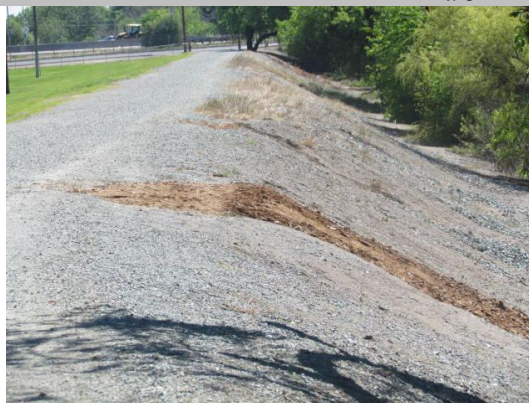
Photo 1 of 1 : richard_s_20140320_073.jpg

LM Start	1.53	Rating **	A/W	Issue No.	9
LM End	1.53	Issue Type +	Ma	Location *	WS
Category	Earthen Levee			GPS Latitude/Longitude	
				Start	End
Item	Slope Stability			37.918529 °	37.918529 °
				-121.295684 °	-121.295684 °
DWR ID	DWR_RD0404_02_f _ 2012_9				
Action/Comments					
Repair the levee slope damaged by foot traffic and prevent access where possible.

Looking east at repaired site on waterward slope.

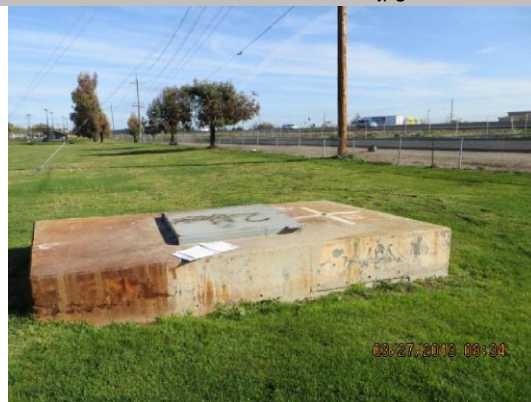
Photo 1 of 1 : UCIP_384.jpg

LM Start	1.76	Rating **	M	Issue No.	19
LM End	1.76	Issue Type +	En	Location *	WS
Category	Supplemental			GPS Latitude/Longitude	
				Start	End
Item	DWR UCIP Field Study			37.917284 °	37.917284 °
				-121.291740 °	-121.291740 °
DWR ID	DWR_RD0404_02_s_2014_19				
Action/Comments					
Inspector Comments: FS_ID:10846					
EP_NO: N/A					
Repair Type:					
Crossing Status:					
UCIP Comments: Only a 7 ft x 14 ft concrete vault found on L. Needs a sign post.					
FIELD_STRUCT_DESC: 1 of 2. 42-inch-diameter pipelines under the levee. Pipes cross under the channel.					
FS Date: 3/27/2013

LS- 7' x 14' concrete vault.
